Re: Turkey Point Unit 4
Docket No. 50-251
Reportable Event: 2000-004-00
Date of Event: October 21, 2000
Loss of Offsite Power and Safety Injection Actuation While in Mode 3

TITLE (4) Loss of Offsite Power and Actuation of Safety Injection While in Mode 3																			
EVENT DATE (5)			LER NUMBER (6)			REPORT DATE (7)			OTHER FACILITIES INVOLVED (8)										
MONTH	DAY	YEAR	YEAR	SEQUENTIAL NUMBER	REVISION NUMBER	MONTH	DAY	YEAR	FACILITY NAME				DOCKET NUMBER						
10	21	2000	2000	- 004	- 00	11	16	2000	FACILITY NAME				DOCKET NUMBER						
OPERATING MODE (9)		3		THIS REPORT IS SUBMITTED PURSUANT TO THE REQUIREMENTS OF 10 CFR §: (Check one or more) (11)															
POWER LEVEL (10)		0		20.2201(b)				20.2203(a)(2)(v)				50.73(a)(2)(i)				50.73(a)(2)(viii)

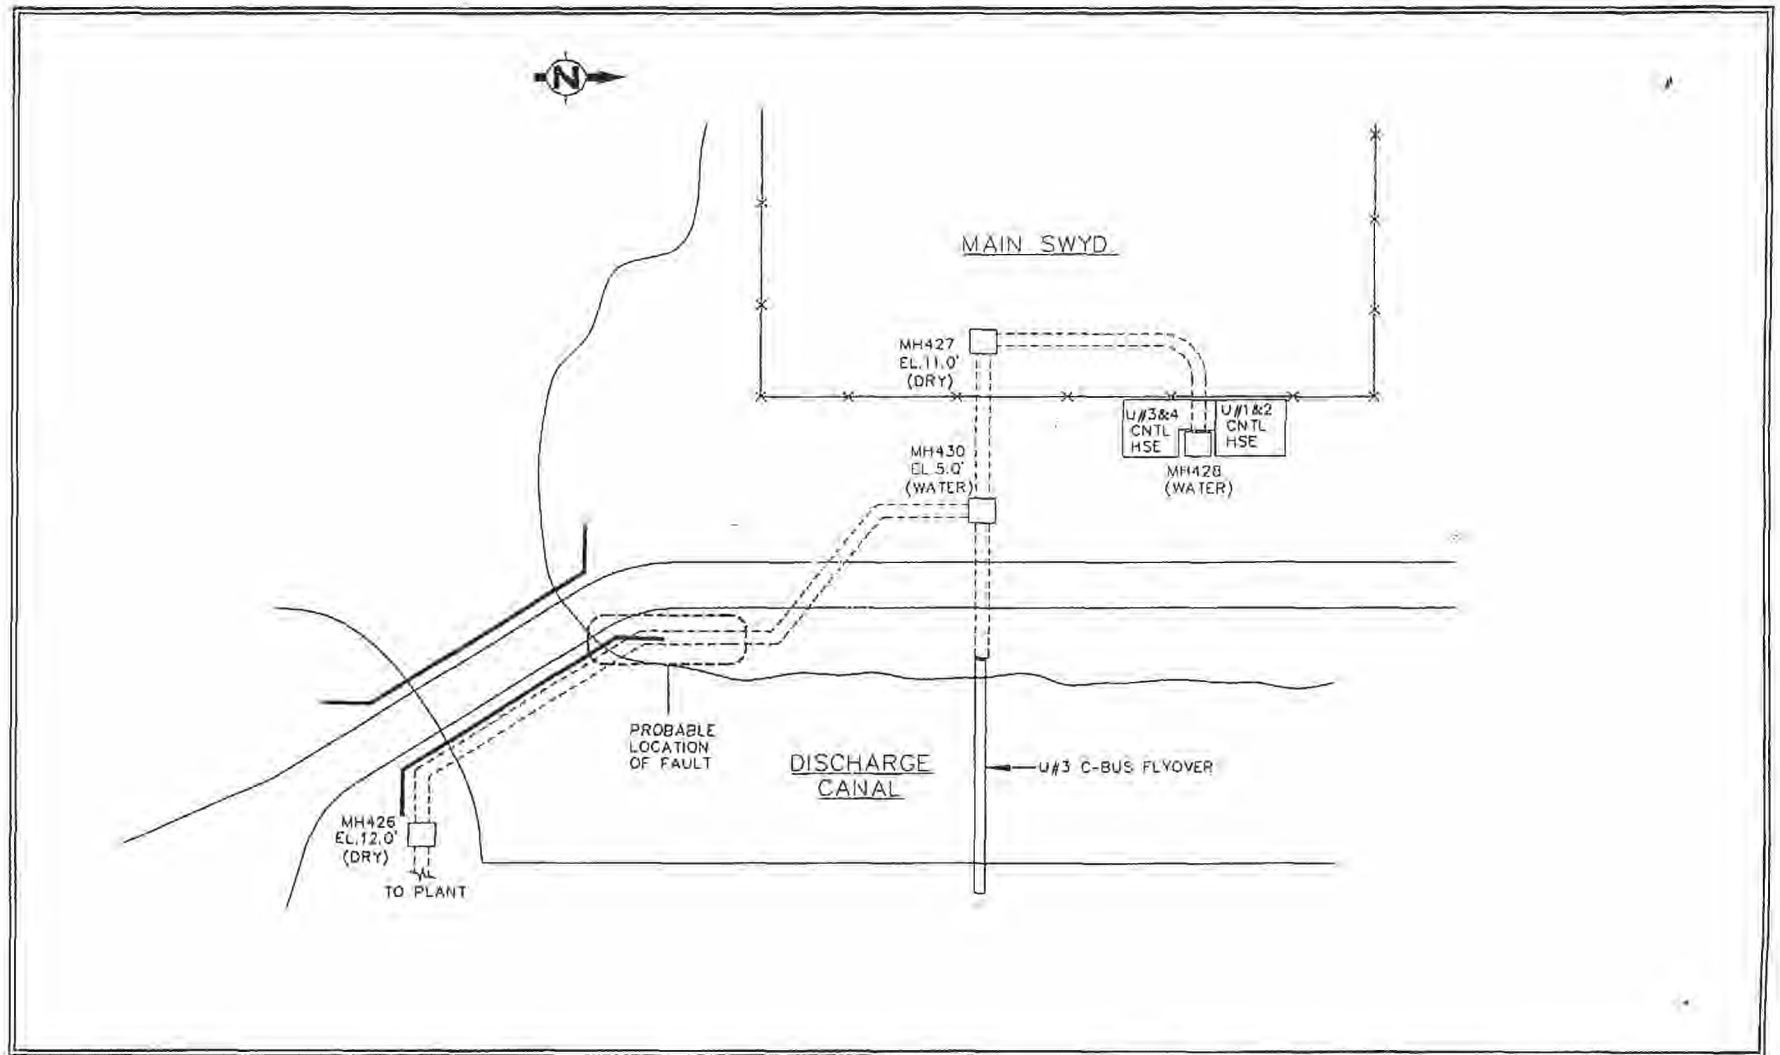
PTN UNIT 4 STARTUP TRANSFORMER PROTECTION CIRCUIT ROUTING

In order to identify the location of the faulted portion of the cable, a Time Domain Reflectometry (TDR) analysis was performed. The fault location was determined to be in underground conduit 4L198 between manholes 426 and 430 (see attached sketch), which are located on opposite sides of a bridge over the condenser discharge canal. In addition to the two cables associated with lockout relay 86/k, six other cables are routed through 4L198. All cables within this conduit were identified and evaluated for potential adverse effect on the Unit 4 startup transformer. It was determined that the failure of any of the other cables in 4L198 would not adversely affect operation of the Unit 4 startup transformer. Engineering identified nine other cables whose potential failure could separate the unit from offsite power while on the startup transformer, and determined that these cables are either not routed in any common raceways with the faulted cable (except for a short section at the switchyard control house) or are protected from physical damage associated with the faulted cable.

The shorting of the two conductors in cable F01/C1709-4C11/4 is the root cause of this event. Based on TDR analysis, the fault location was determined to be in the underground conduit (4L198) between two manholes, (426 and 430), which are located on opposite sides of the bridge over the condenser discharge canal. The specific location of the fault in the cable could not be identified. It is conceivable that some relatively minor damage might have occurred at the time of cable installation while pulling the cable. The area of the faults was in one of the lowest elevation raceways outside the plant protected areas. There was ground water in the raceway as a result of a faulted manhole sump pump.

4. A design package was issued to abandon the shorted conductors and to use the remaining two intact conductors from another cable for Turkey Point Unit 4 backup startup transformer protection.

5. Sump pumps and water level alarm lights were installed/repared in switchyard manholes 427, 428, and 430. These manholes were also added to the plant's severe weather preparation procedure.
